# 天然气冷却器换热管腐蚀原因分析

**摘 要:** 为了确定天然气冷却器换热管腐蚀的原因,应用扫描电子显微镜、能谱分析仪、X 射线衍射仪对某天然气处理厂天然气冷却器换热管的腐蚀形貌、腐蚀产物以及物象进行了分析,同时应用气相色谱仪、模拟试验法、平皿计数法、电化学法对天然气冷却器的工作介质进行了研究。分析和研究结果表明,天然气冷却器换热管腐蚀的主要原因是垢下腐蚀,防腐涂层不合格、缝隙以及细菌的存在进一步促进了垢下腐蚀。在同类工程建设过程中,要注意冷却器水压试验后的干燥、保护和施工过程中的清洁,循环水系统清洗时勿将污垢带入冷却器。换热管外防腐涂层质量不合格不但无法达到保护换热管防止腐蚀的目的,反而会加速局部区域的腐蚀。

## Analysis on corrosion of natural gas cooler heat exchanger tube

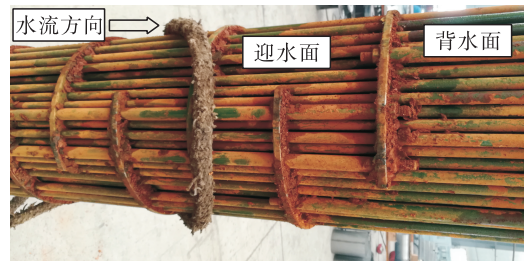
现场对冷却器进行拆解,发现冷却器的管束上沉积了大量垢样,垢样中发现泥沙及铁锈,折流板的背水面堆积的垢样尤为集中,见图 2。

图 2 冷却器管束局部形貌图

1) 换热管束上沉积大量垢样,折流板的背水面堆积的垢样更多。垢样主要含泥沙及铁锈,推断是因为施工时循环水管道未清理干净,循环水系统清洗时未将冷却器隔离,导致循环水总管中大量泥沙进入冷却器,在折流版的背水面大量堆积。

2) 循环水系统施工及完成后,及时清理系统内的杂物。设计时在总管末端设置排污管口及排水措施,总管清洗完成后用盲法兰密封。

3) 在循环水系统循环清洗时,切记将冷却器等设备

进行隔离,循环水在管道内流速较高,进入设备后流速较低,另由于冷却器结构特点,污垢一旦进入设备后,很难通过循环水带出去。

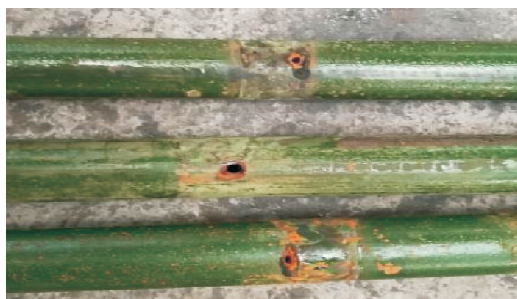
将换热管抽出,查看换热管的腐蚀情况。共有 6 根换热管发生了穿孔腐蚀失效,其他换热管均发现有孔腐蚀,但尚未贯穿。发生孔腐蚀的部位主要位于换热管和折流板接触的区域,见图 3-a);除了在管板接触的区域发生腐蚀之外,在换热管管体(折流板与折流板之间管段)上也发

a) 折流板区域  
a) Baffle region

2) 冷却器壳程进水端(也就是换热管的出气端)内壁的部分垢样被清除后,暴露出大小不一、分布不均的腐蚀坑,这些腐蚀坑主要分布在筒体 6 点钟方向附近区域。由于重力作用,腐蚀产物、泥沙、杂质混合的垢样逐渐沉淀在管板缝隙区域、换热管上方区域、壳程底部区域,折流板背水面区域垢样沉积最多,随着时间的推移,垢样不断沉积,使得垢样下的基体处于无氧状态,加之水中存在溶解氧,使得垢样外区域处于有氧状态,形成氧浓差电池,发生垢下腐蚀。换热管与管板接触的区域存在缝隙,这种缝隙本身由于所处体系的腐蚀性不同可能会发生不同程度的缝隙腐蚀,管板之间的缝隙会加速垢下腐蚀。同时,循环水的 pH 值、工作温度,适宜细菌生长,细菌的存在进一步促进垢下腐蚀。已经发生穿孔的腐蚀坑,其外表形貌具有典型的氧化铁垢下腐蚀水滴状形貌。

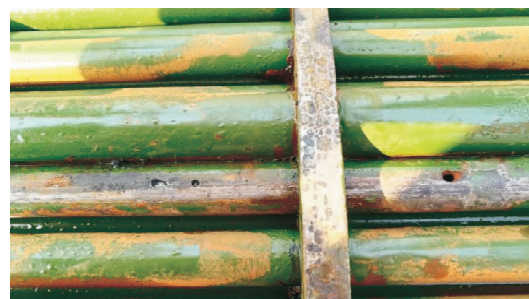
现有近似圆形的腐蚀坑,并未贯穿壁厚,见图 3-b)。

b) 非折流板区域  
b) Non-baffle region

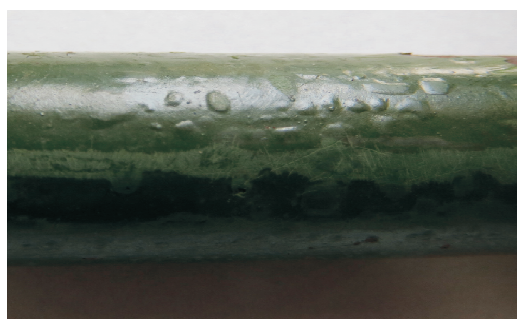
换热管外表面采用淋涂法涂有防腐层,防腐涂料采用由改性耐热环氧有机硅高分子合成树脂、耐热颜料、导热填料配制而成的单组份换热器专用涂料。管束防腐层按机械打砂除锈、管外淋涂、漆膜处理、表干、高温固化施工程序,反复涂装 4 遍,漆膜厚度达 150 μm。有研究已证明,换热管表面涂刷防腐层可有效保护换热管<sup>[20]</sup>。图 4 为放大的换热管防腐层形貌,换热管防腐层

鼓泡现象严重,划开鼓泡区域,换热管已存在腐蚀现象,而未鼓泡区域,换热管状态相对较好。防腐涂层起泡的原因较为复杂,涉及到涂料的性质、施工质量、运行环境等众多因素,本文不再进行深入研究。就结果来看,防腐涂层完好的部位,防腐涂层有效地保护了换热管,但是防腐涂层鼓泡部位,防腐涂层不但没有起到保护换热管的作用,反而加速了换热管的腐蚀。

a) 外防腐层鼓泡形貌  
a) Bubbling appearance of external anticorrosion layer

3) 换热管试样的外防腐涂层均存在鼓泡现象,折流板和换热管接触区域的防腐涂层不完整,鼓泡的外防腐涂层对换热管基体未能起到有效的防腐保护作用;破损的外防腐涂层电阻降低,也会削弱防腐保护效果。

4)有研究已证明,换热管表面涂刷防腐层可有效保护换热管,但需要根据设备运行工况选择合适的防腐涂料并严格控制施工质量。若防腐质量不合格,不但无法达到保护换热管防止腐蚀的目的,反而会加速局部区域的腐蚀。

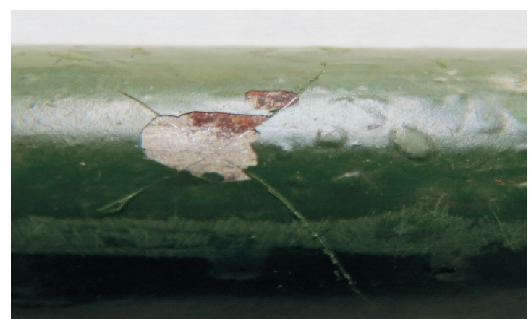
b) 外防腐层鼓泡位置下换热管形貌  
b) Figure of heat exchanger tube under bubbling position of external anticorrosion layer

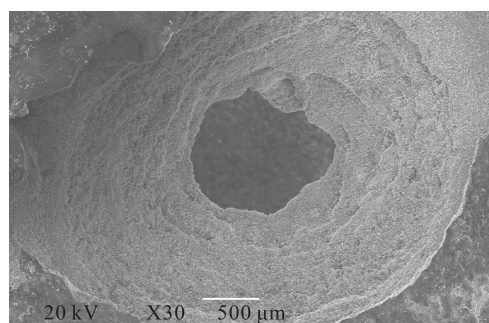
对换热管上的腐蚀坑进行 SEM 检测,整体形貌见图 5-a),局部腐蚀产物形貌见图 5-b)。

a) 腐蚀坑整体形貌

细菌腐蚀的原理是细菌在缺氧条件下繁殖时,将硫酸盐还原并与铁生成硫化铁,形成点状圆形腐蚀坑。鼓风机冷却器换热管上腐蚀坑近似圆形形状,是碳钢发生细菌腐蚀的典型形貌,腐蚀产物分析结果中含有 S 元素,是碳钢发生细菌腐蚀的典型产物。

5)开式循环水系统的 pH 值及工作温度适宜细菌生长,在运行过程中可采用循环水中加投次氯酸钠、液氯、有机氯、无机溴化物等溶剂来抑制异养菌的生长,循环水中氯含量应控制在 0.1 ~ 0.5 mg/L 范围内。

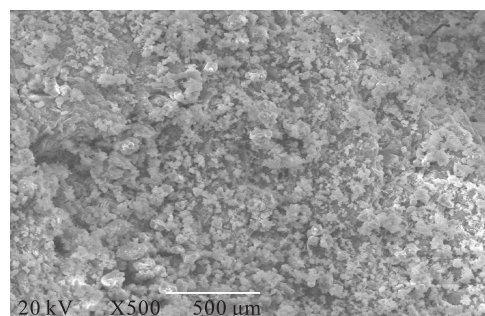
对腐蚀坑底部区域进行能量分散谱(EDS)分析,结果见表 4。腐蚀产物主要包含 C、O、Fe 元素,还包含少量的 S、Si、P、Mg 等元素。

b) 腐蚀产物形貌
